# PEACEHAVEN HUB

Design Report to support submission for CIL funding

FEBRUARY 2024

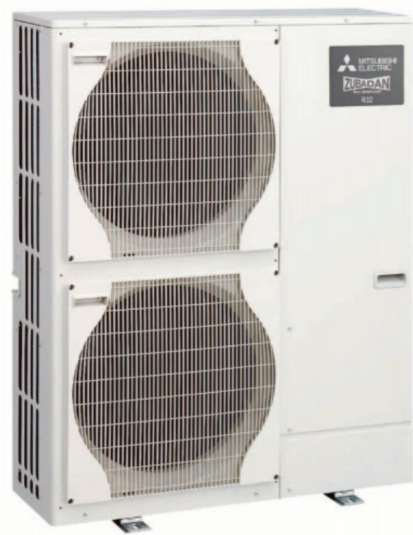
Mitsubishi Ecodan Air Source Heat Pump

The existing gas fired heating system will need to be stripped out and replaced with a heating system sized based upon 55°C flow temperature and 50°C return. There will need to be a buffer vessel and 2 No. Mitsubishi Ecodan R32 14kW Monobloc Air Source Heat Pump Package PUZ-(HWM140VHA). The radiators will need to be replaced with larger heat emitters to operate with the lower water temperature.
